A survey of St James's Church, Lancaut, Gloucestershire

A survey of St James's church, Lancaut, Gloucestershire

By CHARLES PARRY

Summary

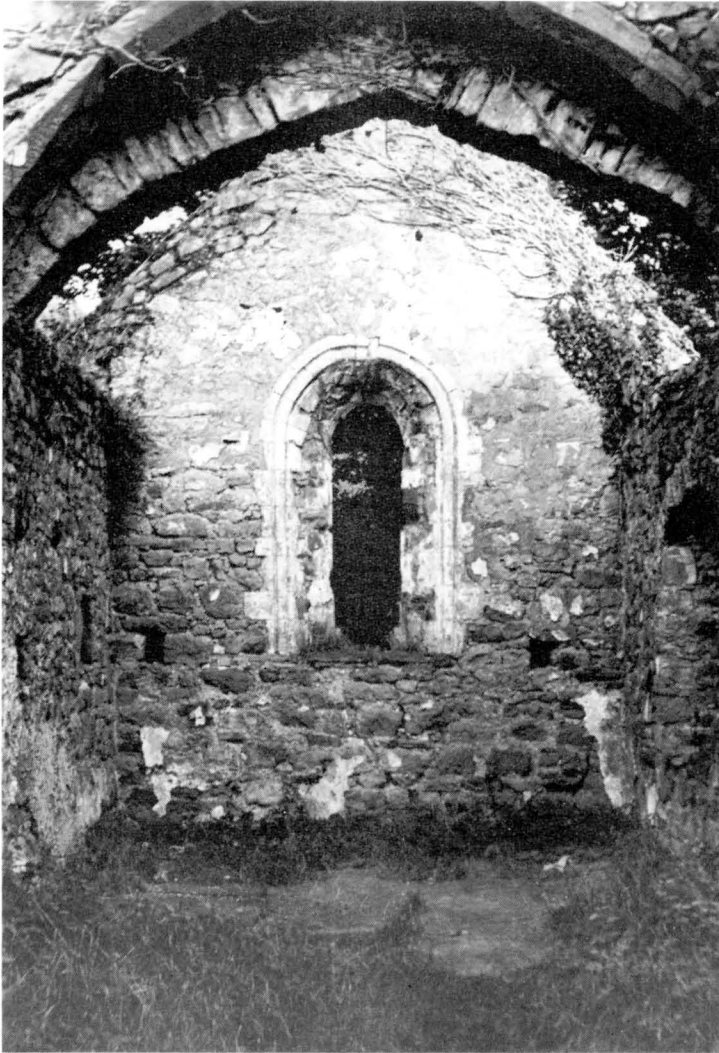
FIG. 11 St James's church; chancel-arch and east window, looking east. Date unknown, but probably *c.* 1930.
Gloucester Library, Gloucestershire Collection 38545 2B.

The east wall of the chancel contains a round-headed window (FIG. 11), doubly splayed, with single roll moulding internally and a double roll externally (FIG. 19). With the exception of one external Old Red Sandstone block, the surround is entirely composed of oolitic limestone. Traces of lime-wash, with red pigment over, were visible on the internal mouldings in 1986. A view of *c.* 1840 (*Ormerod* [11], FIG. 4) shows the window glazed with square panes; glazing-bar holes on the surround corroborate this detail. The flat sill of the window (Dobson and Hicks 1936, plate III) had fallen by 1986 and was restored in 1988. A repair to the soffit of the window arch, using roofing-tile, was observed in 1986. Structural weaknesses in the sill and arch are represented in drawings of *c.* 1840 (*Ormerod* [8], [9], and [10]): one drawing [10] also suggests that the internal arch head had a small keystone which, if present, must have been a plaster feature which has since fallen.

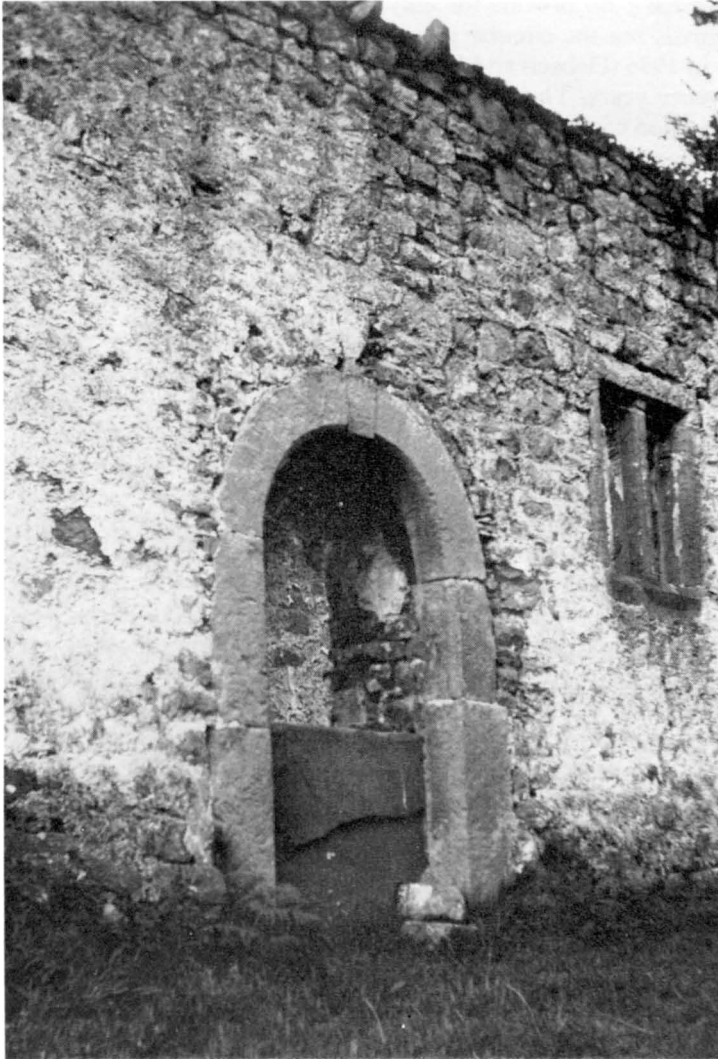
with a keystone and narrow chamfered arch and jambs, was *in situ* in 1969 (Herbert 1972, 77). The nave doorway was reported as 'tumbled down' in 1954 (Grigson 1954, 2308), but this is a mistaken reference to the chancel doorway. Photographs (Glos R.O. D 392/145; G.L. 38545 2D, FIG. 13) record the appearance of the doorway-surround before its removal.

East of the doorway is a lintel-headed window (0.82 m by 0.72 m), set flush with the external elevation. It was originally of two lights, but its central mullion had probably gone by the 1930s, for it was not mentioned by Dobson and Hicks (1936). The jambs of the surround are splayed (FIG. 19), and the lintel has a narrow chamfer along its bottom external edge. Two iron brackets on the west jamb indicate that a single shutter was once in use. No glazing-bar holes are present on the surround, although a sketch of c. 1843 (*Johnson*, FIG. 3) shows a diamond pattern of glazing leads in both lights, and no shutter. Under the lintel, a thin iron bar with a series of small holes probably held glazing leads in place, and can be presumed to be a later insertion, although no evidence for this could be seen. Each window-splay contains a large stone with striations (chisel markings?) running diagonally across it. The masonry above the splay of the window opening is supported by a segmental rere-arch.

FIG. 13 St James's church; nave doorway and south window.
Date unknown, but before 1936.
Gloucester Library, Gloucestershire Collection 38545 2 D.

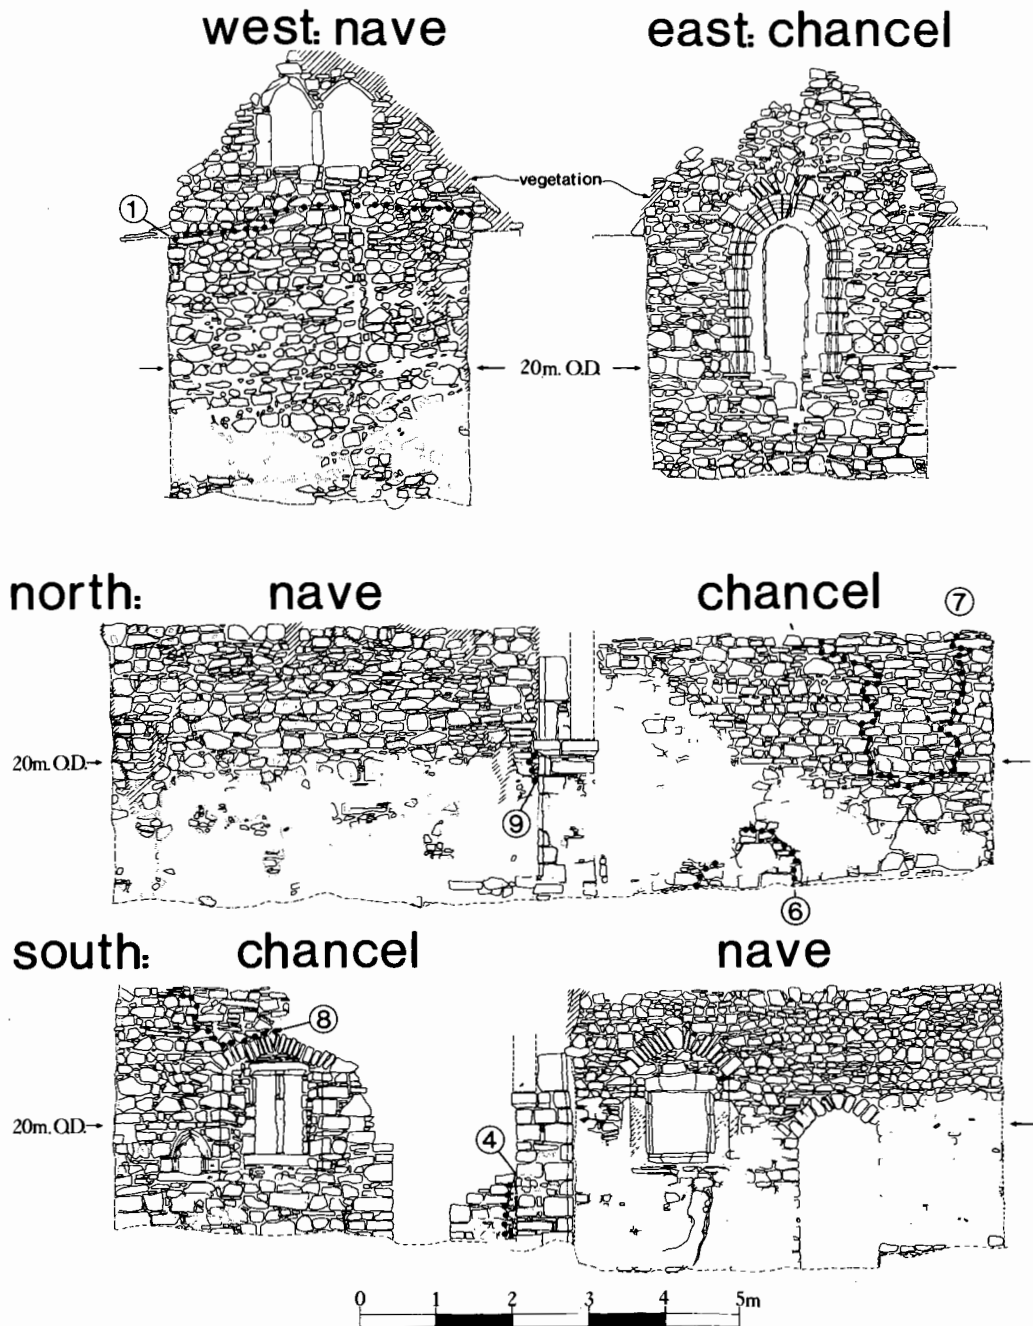
FIG. 16 St James's church; internal elevations, 1986.

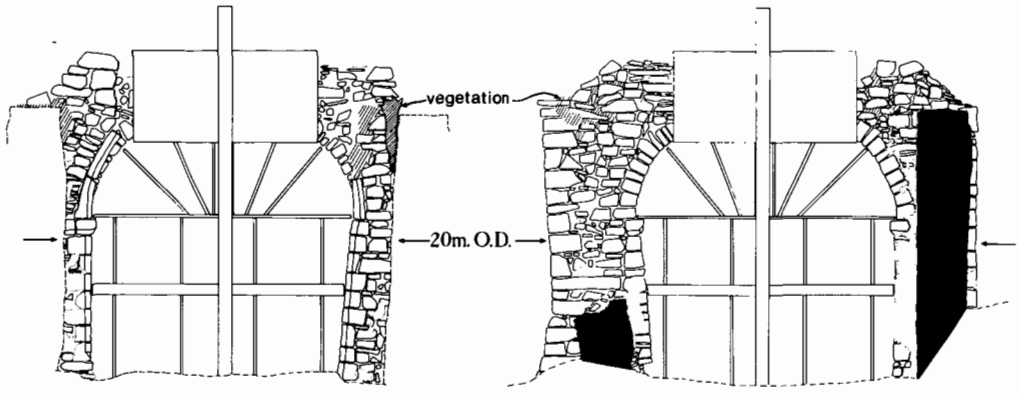
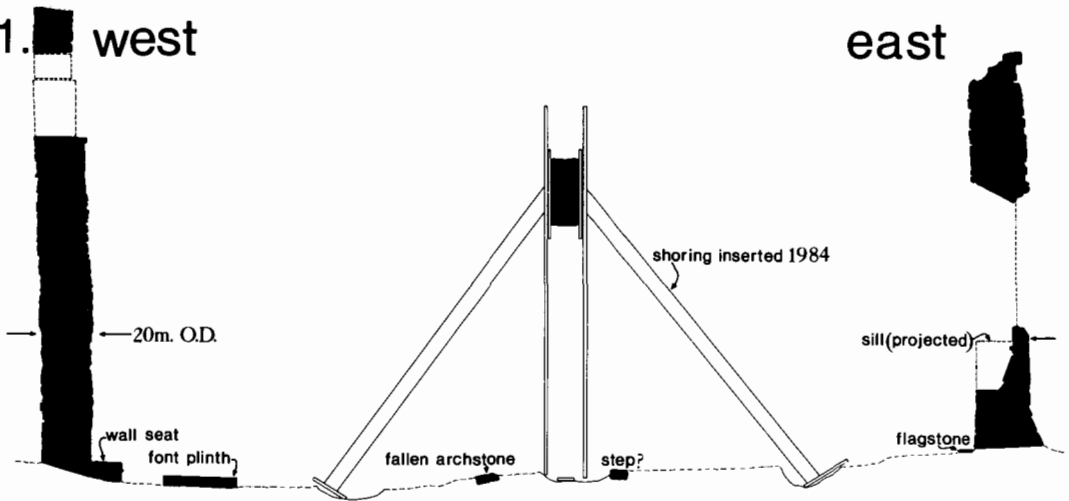
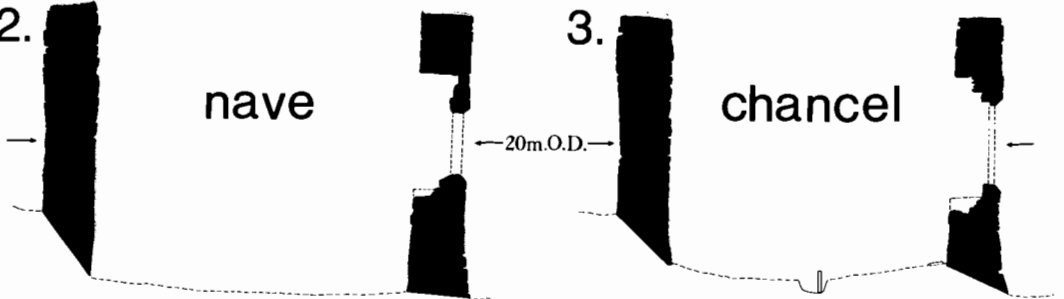
have occurred just east of the chancel-arch, where a line of stones (marked step? on FIG. 17) runs approximately north-south across the width of the chancel. The interpretation is uncertain, for it may be significant that the alignment of this feature appears to relate to the orientation of the south wall of the nave, rather than to the church in general. If not a step, its function can only be guessed, for it does not appear on Ormerod's plan, (*Ormerod* [12], FIG. 5) which shows two steps central to, and immediately east of, the chancel-arch. As mentioned briefly above, the height of the base of the north jamb of the chancel-arch might also indicate that the chancel floor once extended as far as the west jambs of the chancel-arch.

FIG. 17 St James's church; above: chancel-arch elevations, 1986, below: profiles 1-3, 1986.

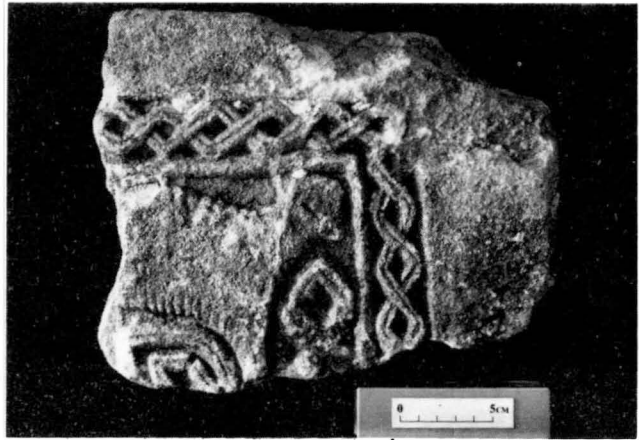
Nevertheless, a piece of dating evidence for Fabric 1 was discovered during the consolidation programme of 1987–1988, when a decorated limestone slab (FIG. 23), with traces of Type 1

1. FIG. 23 211 mm × 257 mm (decorated face), depth 61 mm. Oolitic (Crease?) limestone
 Found re-used as a facing stone on the external north wall of the nave when a portion of this was dismantled before reinstatement during the consolidation programme of 1987–1988. The stone is broken and damaged but appears to represent the corner of a panel decorated in low relief up to 9 mm deep. The reverse of the stone is shaped roughly flat but is not smooth. The intact edges are smooth. Three bands of decoration form a border. The outer band consists of a plain undecorated area, between 51 mm and 79 mm broad. The middle band is between 30 mm and 36 mm broad, and contains interwoven strands with a shallow, incised groove. The innermost band is a 10 mm wide bead moulding. The decoration enclosed within the border is not interpretable with certainty, for two interpretations of it are possible. Adjacent to the broken edge of the slab is an eye-like motif, possibly indicating that a (?human) face was the intended representation. If an eye, the design above could be interpreted as some form of headgear, possibly a crown or a helmet; alternatively, the 'headgear' might be viewed as an animal, possibly a lamb or sheep, with its body shown in profile and its head viewed as if from above. The interpretation is inferred from delicately moulded 'ears' projecting either side of the head of the animal, and striations (above the eye-like motif) which may represent a fleece hanging underneath the body of the animal. This piece requires further study in the light of comparative material.

FIG. 23 St James's church; decorated stone no. 1. Photographed by S. Dorey for Gloucestershire County Council.

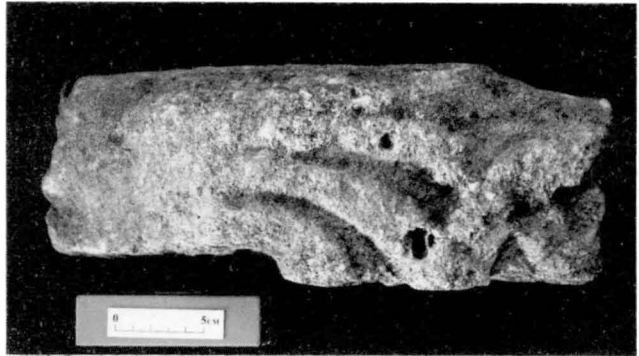
2. FIG. 24 321 mm × 116 mm (decorated face) × 152 mm. Oolitic (Crease?) limestone
 Found lying loose amongst rubble in the south-east corner of the chancel when the church was cleared at the commencement of the survey in 1986. One face only has decoration consisting of four arcs, three of which run in the same direction. The fourth, running in an opposing direction, overlies two of the others. The relief is a maximum of 7 mm deep. The reverse side of the stone is smooth and flat. The other edges are

FIG. 24 St James's church; decorated stone no. 2. Photographed by S. Dorey for Gloucestershire County Council.

rough and pitted. Below the decoration is a slight rebate, but it is impossible to determine whether this reflects the shape of the stone as it was originally cut, or whether it is due to re-use of the stone.

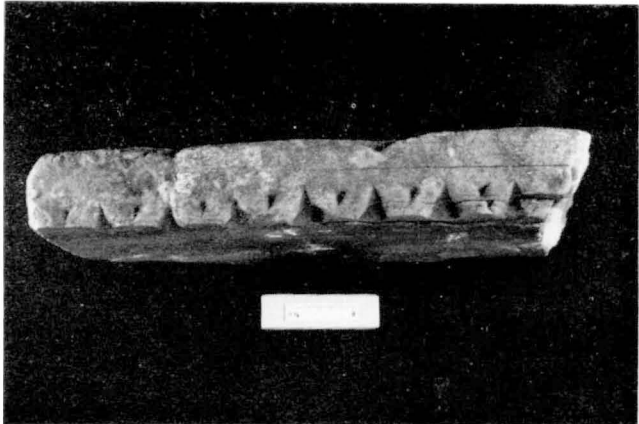
The Transitional structure may have had some decoration. The slab carved with dog-tooth motif (FIG. 25) probably belonged to it, as may the design of the east window of the chancel. However, the composite chancel-arch, with simple chamfer on the western side only, must have presented a decidedly plain and rustic appearance.

FIG. 25 St James's church; decorated stone no. 3. Photographed by S. Dorey for Gloucestershire County Council.

3. FIG. 25 570 mm × 71 mm (decorated face) × 212 mm. Old Red Sandstone

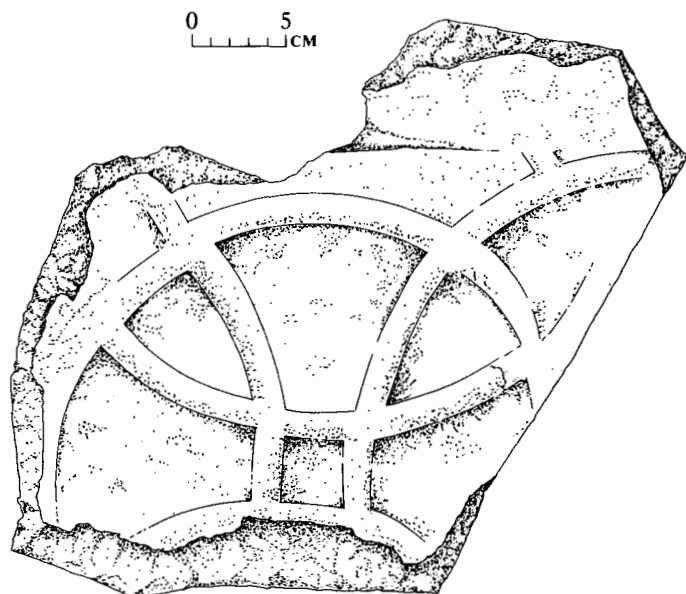
4. FIG. 26 400 mm × 270 mm (decorated face) × 60 mm (minimum). Sandstone (type unknown)

FIG. 26 St James's church: decorated stone no. 4.
